Re: July 2012 Monthly Progress Report
Administrative Settlement Agreement and Order on Consent for Removal Action
U.S. EPA Region 10 Docket No. CERCLA 10-2009-0255
Gasco Sediments Site within the Portland Harbor Superfund Site

Attachment A Monthly Visual Monitoring Report for Pilot Cap Vicinity

Visual Observations Log Form

Monitoring Period: Monthly (Year 6)—July 2012

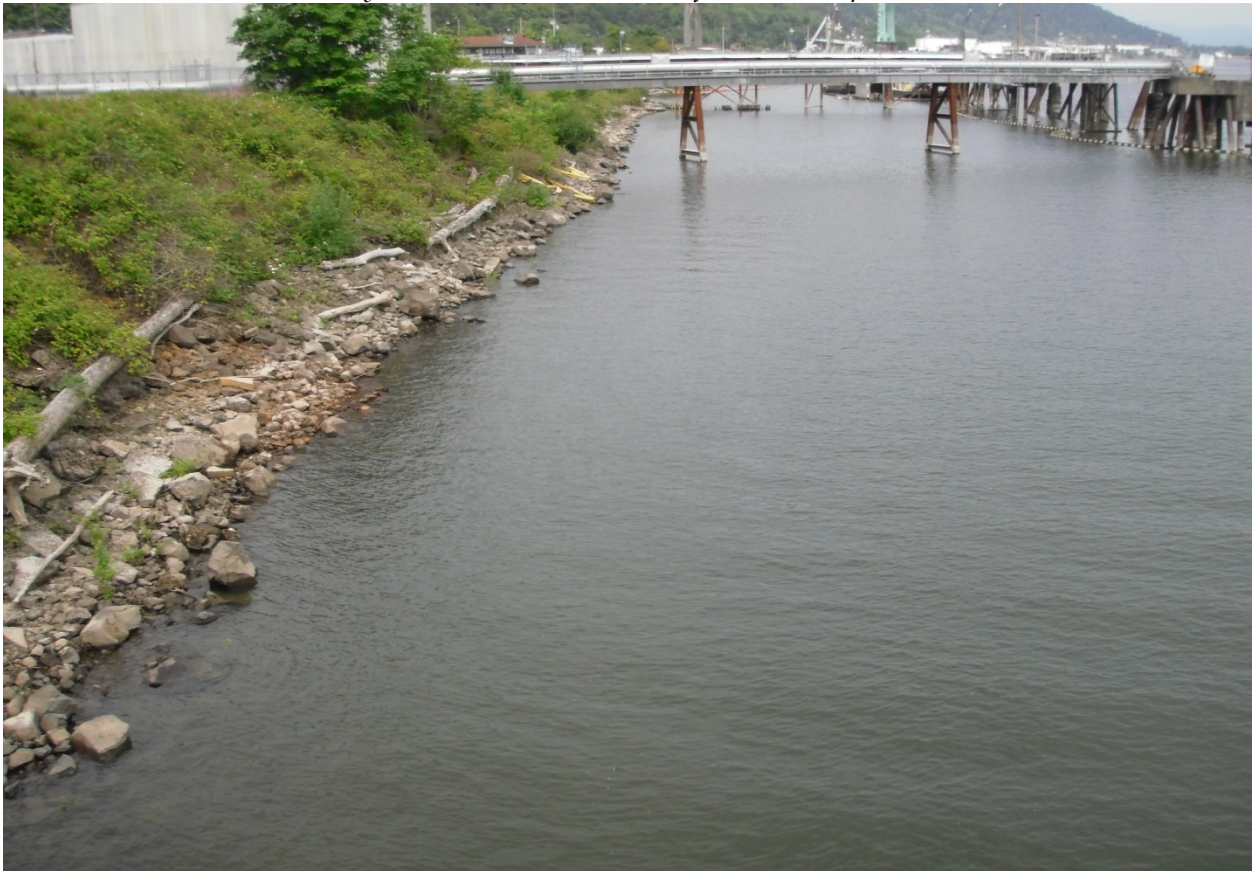
Observations of Erosion/Deposition: No erosion/deposition is evident along the shoreline. The shoreward extent of the cap was not visible due to high river water elevation; and the extents of the organoclay mat material were also submerged. (Photo 1).

Photo 1 — *River level currently elevated above the extent of sediment cap (7/17/12):*

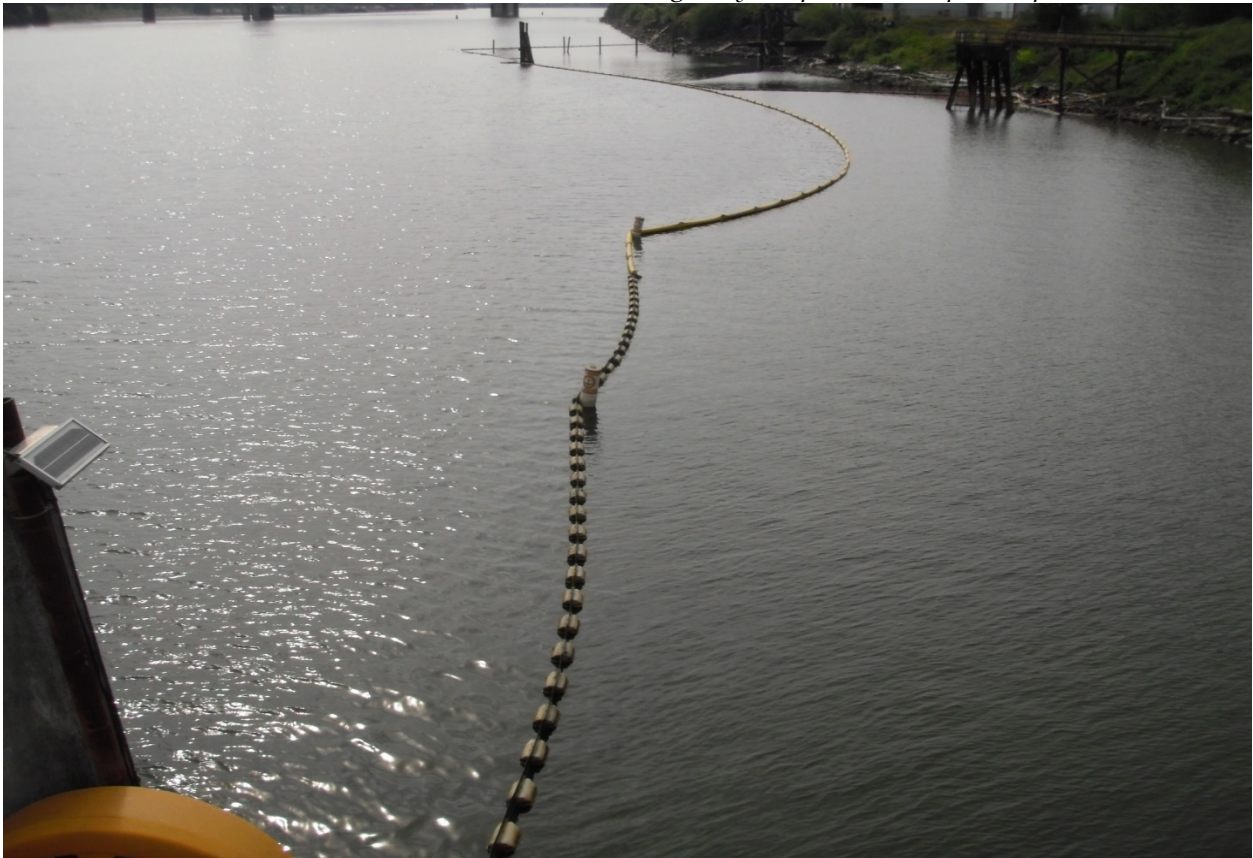
Observations of Long-term Controls (i.e., oil booms, organo-clay mat, etc.) During the observation, the Fuel and Marine Marketing (FAMM) containment boom was placed across the cap area, between the upriver corner of the ship dock and the wooden dolphin (near the upriver extent of the site and near the Siltronic Corporation outfall). Buoys that identify the cap area to mariners are in place as installed. The position of the FAMM oil boom, warning buoys, and a general overview of the site shoreline is shown in Photo 2.

Photo 2 — *FAMM oil boom shown and mariner warning buoys in place across pilot cap area. 7/17/12):*

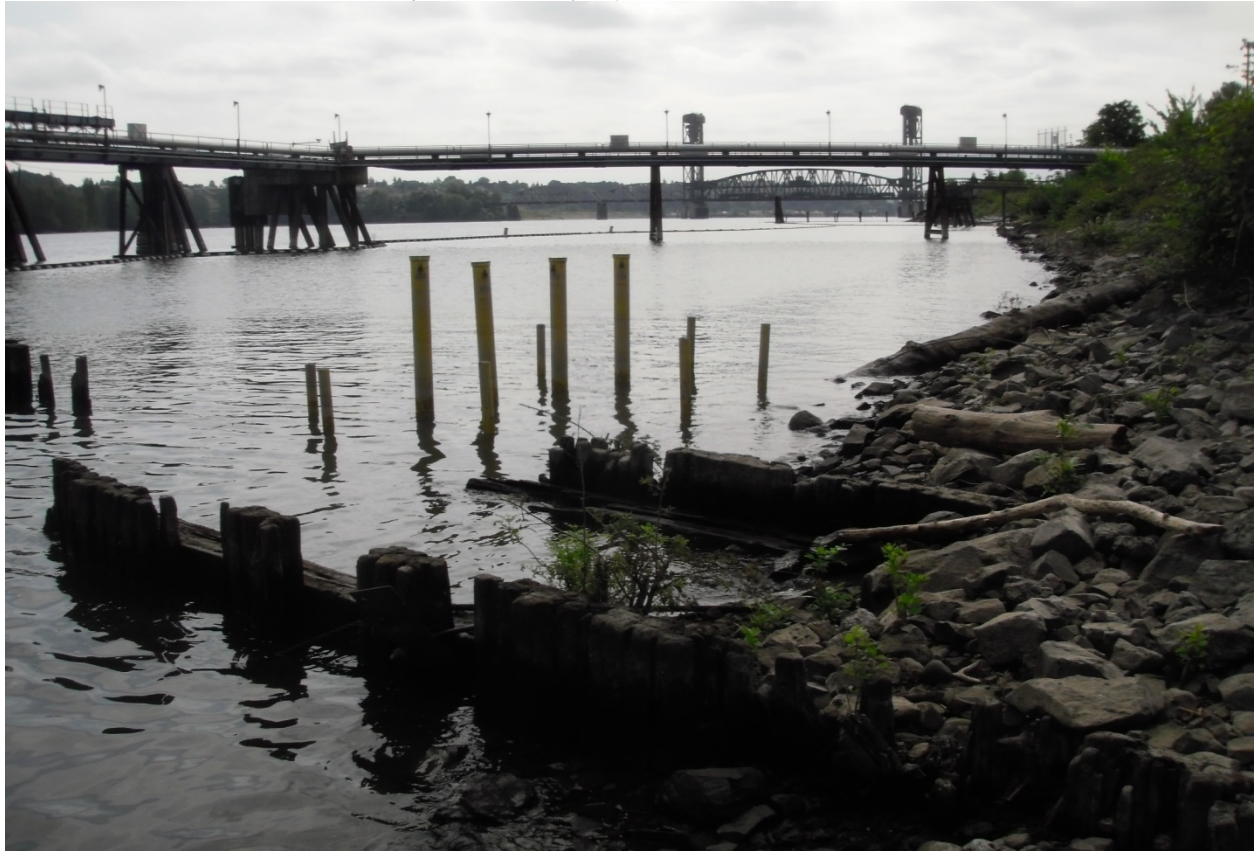
Other Comments: No sheen is evident in or around the cap area. Photo 3 shows the water surface and shoreline immediately downriver of the sediment cap.

Photo 3 — *Conditions immediately downriver of cap area (7/17/12):*
